**Flood Control Project Maintenance
Levee Inspections**

Fall 2012 Levee Maintenance Deficiency Summary Report

Levee Inspection Report By Mile - Fall 2012

Marysville Levee Commission

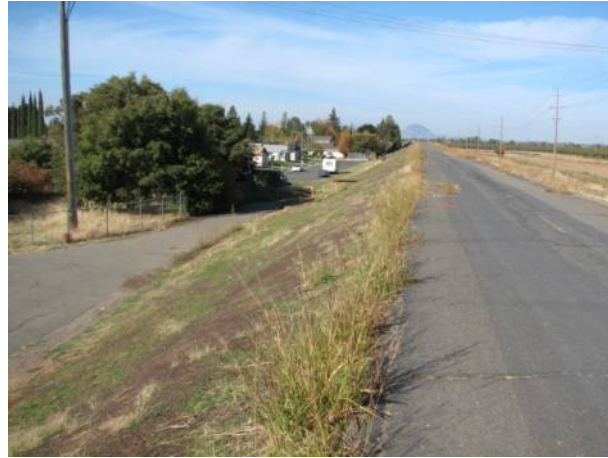
Levee Mile Report Line	4
Start Levee Mile	0.00
End Levee Mile	3.20
Location	Land Side
Category	Earthen Levee
Item	Vegetation

This photo shows the landside slope of the levee at levee mile 3.20.

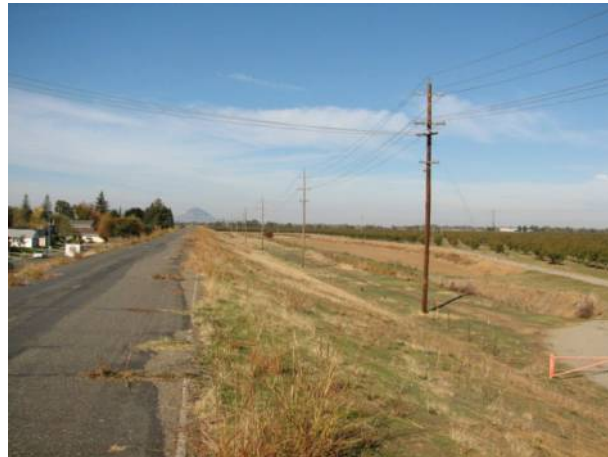
Levee Mile Report Line	5
Start Levee Mile	0.00
End Levee Mile	3.20
Location	Water Side
Category	Earthen Levee
Item	Vegetation

This photo shows the waterside slope of the levee at levee mile 3.20.

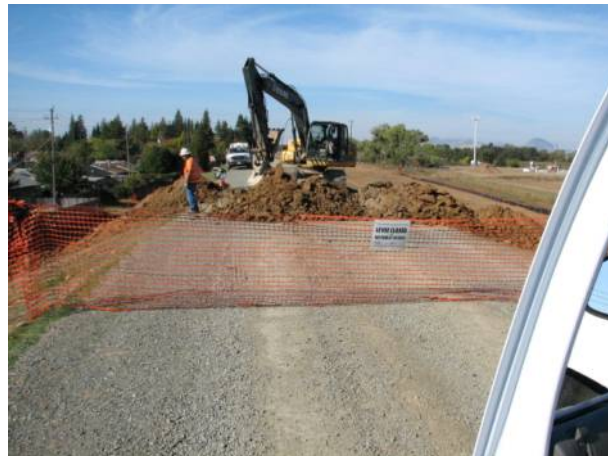
Levee Mile Report Line	6
Start Levee Mile	1.17
End Levee Mile	2.46
Location	Crown
Category	Earthen Levee
Item	Encroachments

Levee repair work on process.

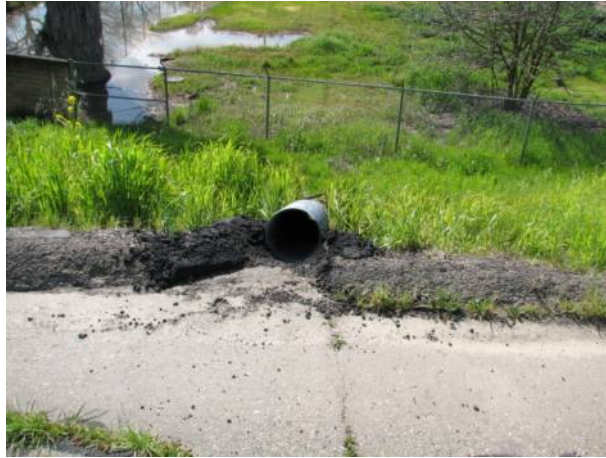
Levee Mile Report Line	7
Start Levee Mile	3.21
End Levee Mile	3.21
Location	Land Side
Category	Earthen Levee
Item	Slope Stability

This site is on the Corps PI.

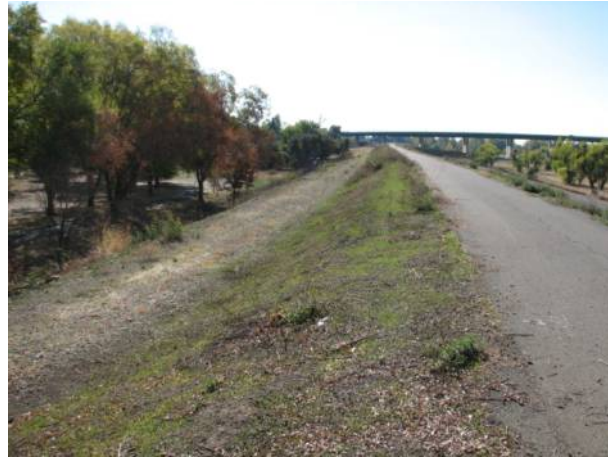
Levee Mile Report Line	1
Start Levee Mile	0.04
End Levee Mile	1.25
Location	Land Side
Category	Earthen Levee
Item	Vegetation

This photo shows the landside slope of the levee at levee mile 0.00.

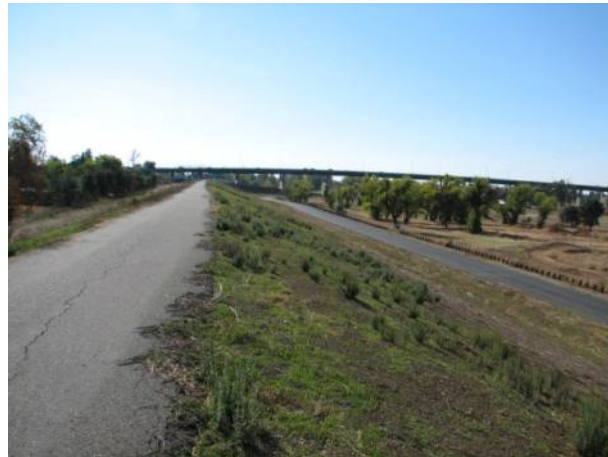
Levee Mile Report Line	2
Start Levee Mile	0.04
End Levee Mile	1.25
Location	Water Side
Category	Earthen Levee
Item	Vegetation

This photo shows the waterside slope of the levee at levee mile 0.00.

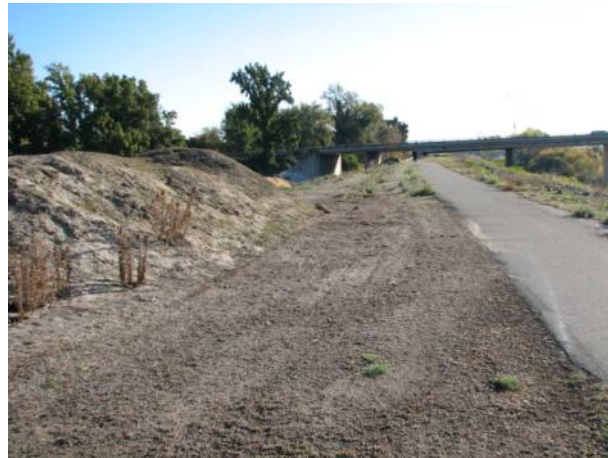
Levee Mile Report Line	1
Start Levee Mile	0.17
End Levee Mile	4.86
Location	Land Side
Category	Earthen Levee
Item	Vegetation

This photo shows the landside slope of the levee at levee mile 0.17.

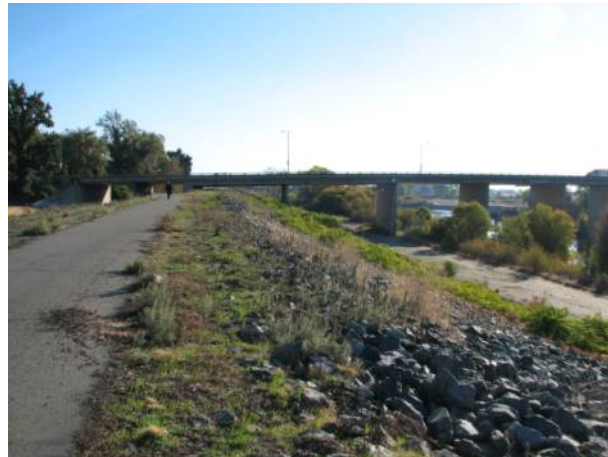
Levee Mile Report Line	2
Start Levee Mile	0.17
End Levee Mile	4.86
Location	Water Side
Category	Earthen Levee
Item	Vegetation

This photo shows the waterside slope of the levee at levee mile 0.17.

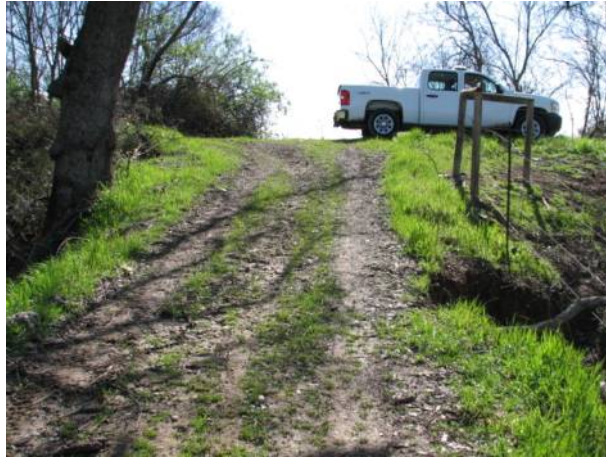
Levee Mile Report Line	6
Start Levee Mile	5.54
End Levee Mile	5.54
Location	Crown
Category	Earthen Levee
Item	Encroachments

DWR ID: DWR_NA0004_03_s_2012_1										
6	5.54	5.54	Earthen Levee	Encroachments	CR	M En	RA : Ramp Inspector Comments: This is on the patrol road.	39.190993 ° -121.530650 °	39.190993 ° -121.530650 °	10 Y
DWR ID: DWR_NA0004_03_s_2012_10

This ramp is on the patrol road, no known permit.
